Case Study: Component Wear due to Contamination

Model: Off Highway Truck
Compartment: Wheel Bearing

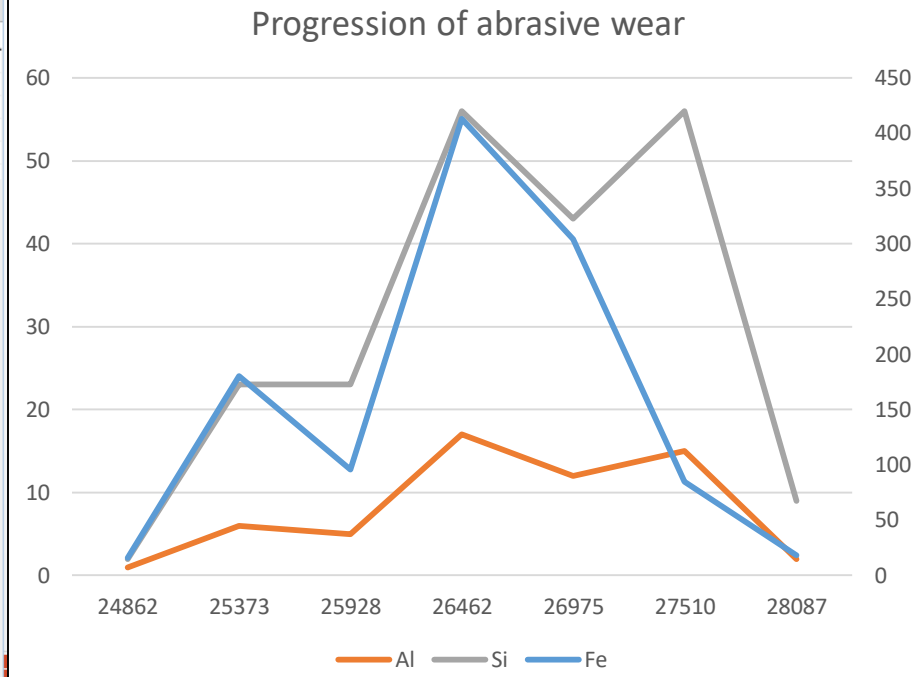
Result during dirt ingestion period

IRON IS STILL HIGH. THIS COULD BE FROM GEARS WEAR. SUSPECTED DIRT CONTAMINATION PROBLEM STILL PERSISTS. CHECK SOURCES OF DIRT ENTRY. CHECK MAGPLUG FOR ABRASIVE WEAR PARTICLE. CHECK SEALS FOR OIL LEAK, INSPECT, REPAIR IF NECESSARY.

Increase in Aluminium and Silicon are indicating dirt contamination in the system. Fine particles caused by abrasive wear found in magnetic plug. Abrasive wear is the predominant wear mode causing wear in roller race , gears and housing. Machine was inspected and found dirt contamination due to leakage in seals. Components found okay and fit for reuse. Seals and O rings are replaced to resolve this issue. Recheck result found okay.
