Case Study: Component Wear due to Contamination

Model: Off Highway Truck
Compartment: Wheel Bearing

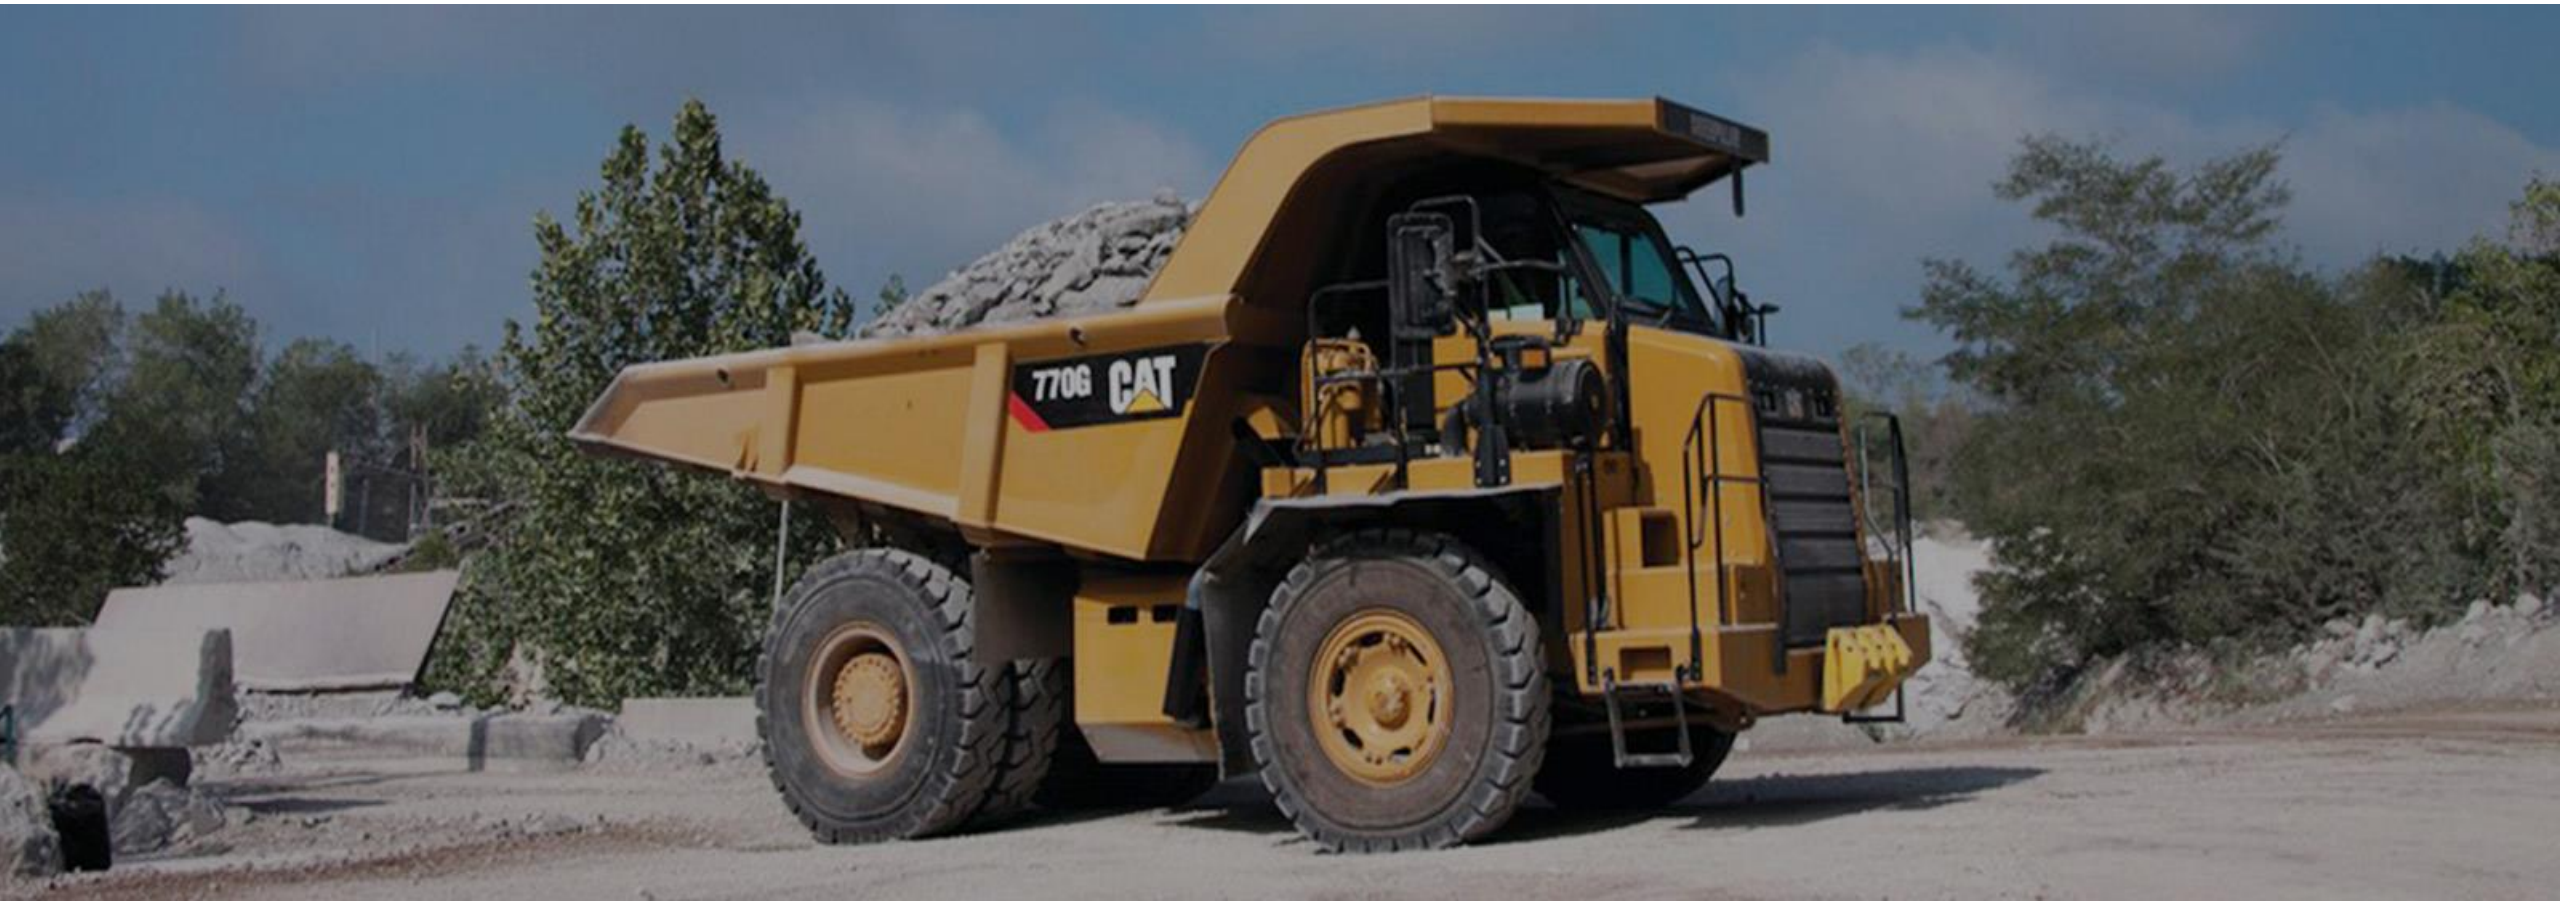
Result during dirt ingestion period

Sample					Wear Metals																							
Login Date	Sampled Date	Text Id	Meter	Meter on Fluid	Ag	Cu	Fe	Cr	Pb	Sn	Mn	Ni	Ti	Al	Si	Na	K	P	Zn	Ca	Mg	Mo	B	Ba	Cd	V	S	
29-JAN-20	20-JAN-20	J250-50029-0046	26975.0	512.8	0	0	x304	0	1	0	2	0	1	x12	x43	7	1	293	22	266	10	0	153	2	0	0		
20-DEC-19	16-DEC-19	J250-49354-0032	26462.2	534.2	0	1	x413	1	0	0	3	0	1	x17	x56	7	2	315	30	280	24	1	68	3	0	0		
25-NOV-19	17-NOV-19	J250-49329-0084	25928.0	554.5	0	0	x96	0	1	0	1	0	0	~5	23	6	0	283	11	261	1	0	87	1	0	0		
01-OCT-19	27-SEP-19	J250-49274-0039	25373.5	511.1	0	0	x180	0	0	1	1	0	0	x6	23	12	4	291	18	281	4	0	187	1	0	0		
17-AUG-19	11-AUG-19	J250-49229-0092	24862.4	487.9	0	1	16	0	0	0	0	0	0	0	2	10	2	308	25	297	1	0	129	0	0	0		
19-JUL-19	01-JUL-19	J250-49200-0045	24374.5	478.5	0	0	x96	0	0	0	1	0	0	~5	13	5	2	260	11	245	1	0	118	1	0	0

IRON IS STILL HIGH. THIS COULD BE FROM GEARS WEAR. SUSPECTED DIRT CONTAMINATION PROBLEM STILL PERSISTS. CHECK SOURCES OF DIRT ENTRY. CHECK MAGPLUG FOR ABRASIVE WEAR PARTICLE. CHECK SEALS FOR OIL LEAK, INSPECT, REPAIR IF NECESSARY.

Increase in Aluminium and Silicon are indicating dirt contamination in the system. Fine particles caused by abrasive wear found in magnetic plug. Abrasive wear is the predominant wear mode causing wear in roller race , gears and housing. Machine was inspected and found dirt contamination due to leakage in seals. Components found okay and fit for reuse. Seals and O rings are replaced to resolve this issue. Recheck result found okay.
